Manhole Inspection Summary

Manhole # S35YY_037MH

Insp Date: **12/22/06 9:45 AM**

Location Address: **3137 CALVERT ST**

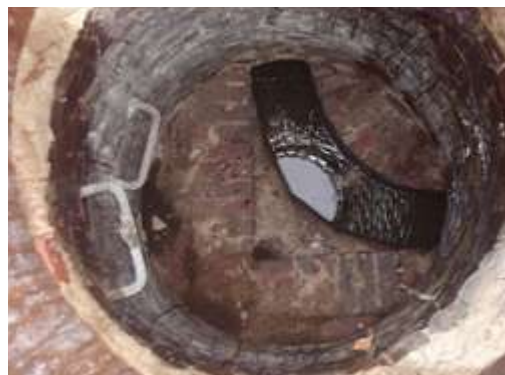
Top View

Barrel infiltration. Bench debris.

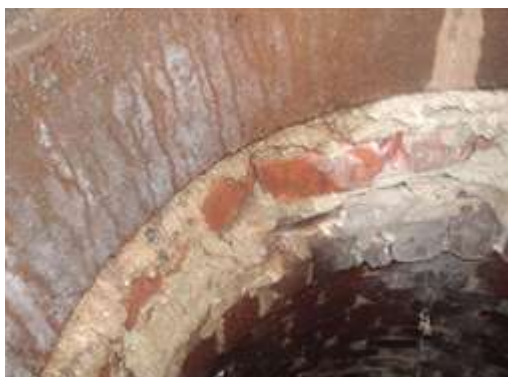
Defect

Frame leaks. Adjustment deterioration and infiltration.

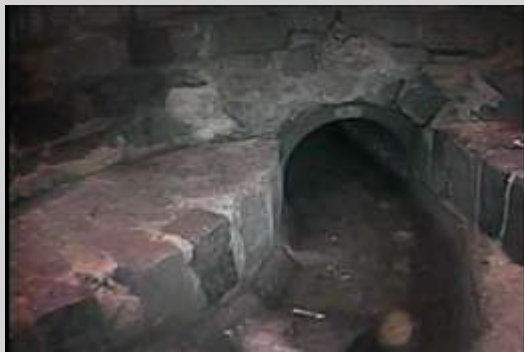
8 in. Circular Gravity Sewer Pipe Out @ 12 O'Clock

Deposits: ☐ None ☒ **Mud** ☐ Sludge ☒ **Debris** ☐ Grease

Silt Depth: **2** (in.) Deposits Extent: **Light**

Infiltration: **Evidence** Pipe Seal Cond: **Unknown**

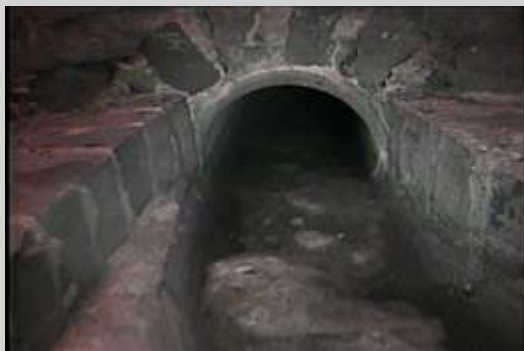
8 in. Circular Gravity Sewer Pipe In @ 9 O'Clock

Deposits: ☐ None ☒ **Mud** ☐ Sludge ☒ **Debris** ☐ Grease

Silt Depth: **2** (in.) Deposits Extent: **Light**
